BOCA VERDE

Boca Verde C.A.
Boca Raton, FL

Report #: 52294-0
Beginning: January 1, 2025
Expires: December 31, 2025

RESERVE STUDY
"Full"

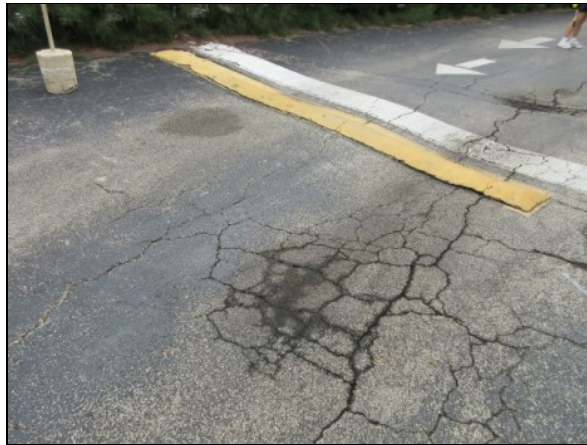
Useful Life:
4 years

Remaining Life:
1 years

Best Case: \$ 14,200

Worst Case: \$ 17,300

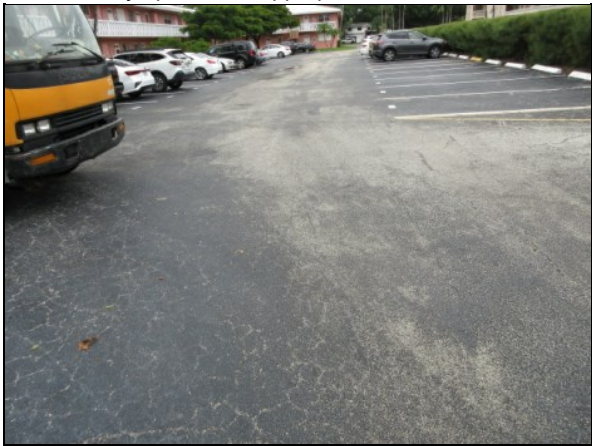
Useful Life:
20 years

Remaining Life:
0 years

Best Case: \$ 124,000

Worst Case: \$ 152,000

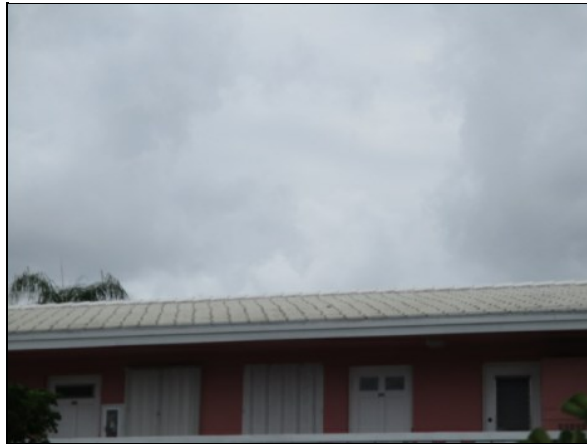
Remaining Life:

14 years

Best Case: \$ 907,000

Worst Case: \$ 1,110,000

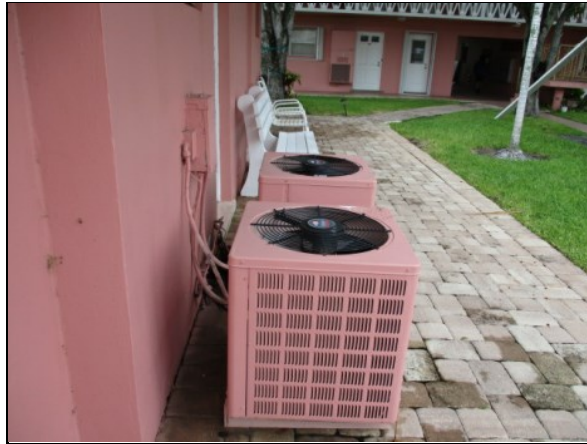
Useful Life:
15 years

Remaining Life:
4 years

Best Case: \$ 11,700

Worst Case: \$ 14,300

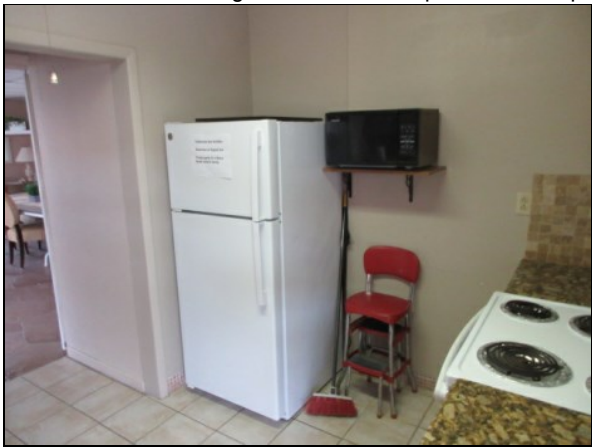
Useful Life:
20 years

Remaining Life:
5 years

Best Case: \$ 18,000	Worst Case: \$ 22,000
Lower allowance to renovate/remodel	Higher allowance
Cost Source: AR Cost Database

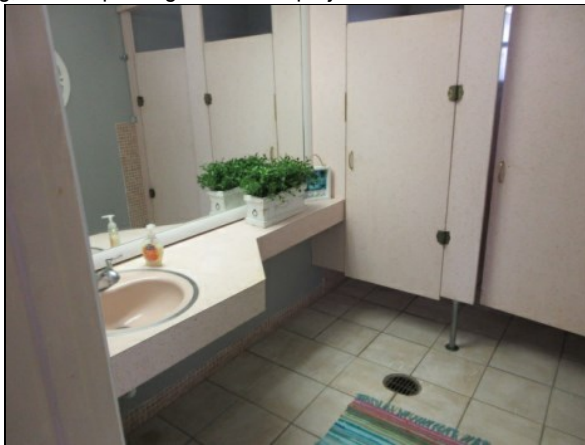
Comp #: 2749 Bathrooms - Remodel

Useful Life:
20 years

Remaining Life:
5 years

Best Case: \$ 17,000

Worst Case: \$ 20,700
